Associated British Ports – Immingham, Biomass Silo Inspections & Maintenance

Overview

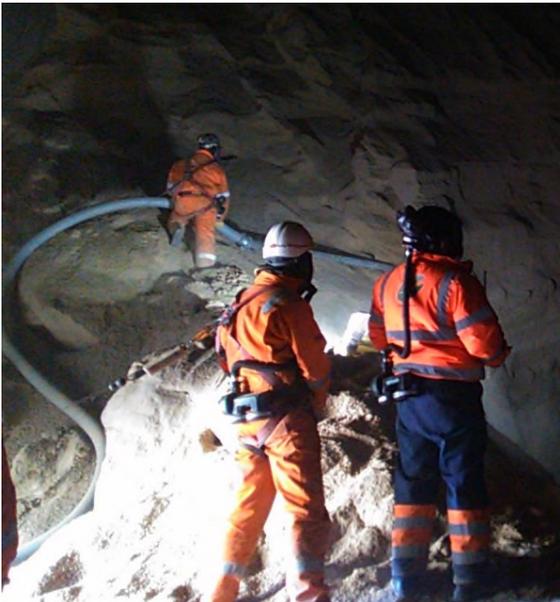
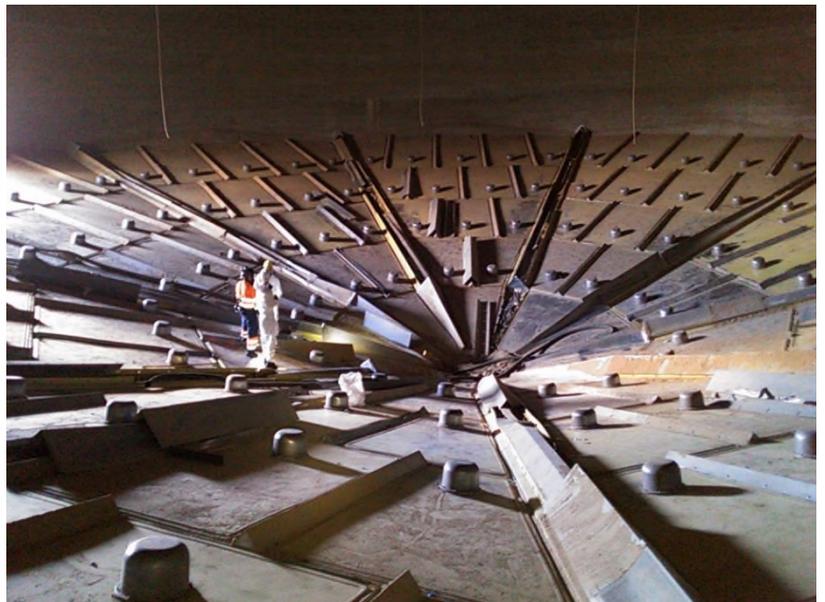
We gained controlled access through the silo doors, initially removing any build-up of material directly behind the access door using a vac tanker to pump out the material. Following removal of all the build-up material, the access doors were fully opened, and the team safely entered the silo. Any remaining material was then loosened and emptied using the vibro floors. Once the silo was fully emptied, we were able to carry out the inspections.

All 4 silos were safely emptied, and inspections were completed to stiffener plate bolts, sensors, cable way and valves and membrane. We also made repairs to damaged vibrafloor plates, replaced the membrane and made ducting repairs.
